Manhole Inspection Summary

Manhole # S45WW_007MH

Insp Date: **3/28/07 9:30 AM**

Location Address: **2926 JENIFER AVE**

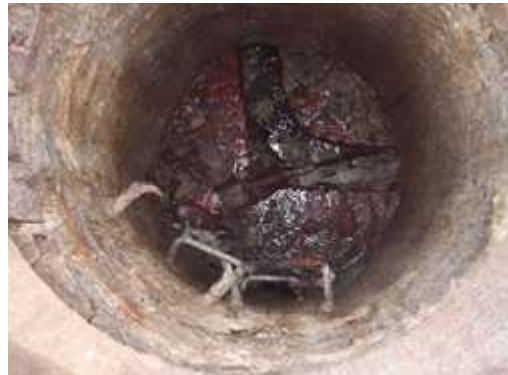
Top View

Corroded and missing steps. Evidence of surcharge - Bench debris. Channel debris.

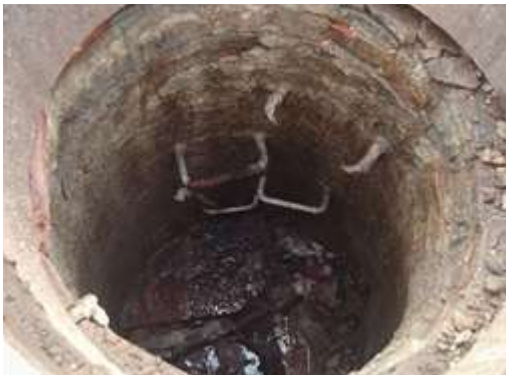
Defect

Frame leaks. Frame offset. Adjustment deterioration and infiltration. Corbel infiltration.

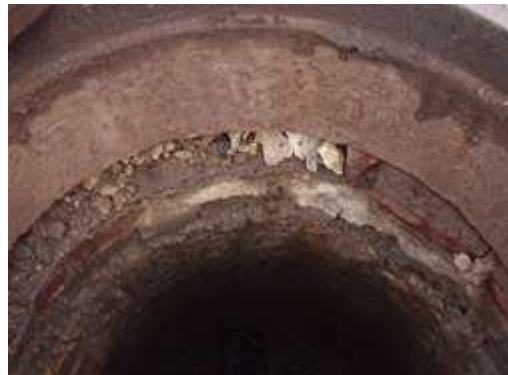
Frame leaks. Frame offset. Adjustment deterioration and infiltration.

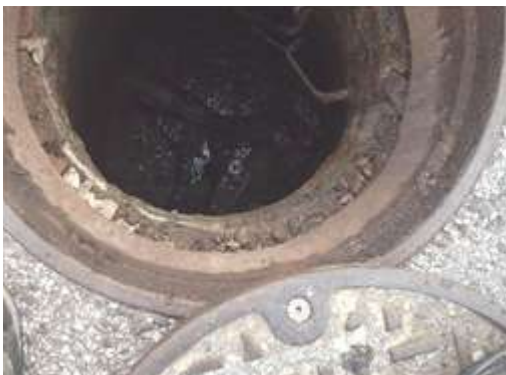
Defect

Frame leaks. Frame offset. Adjustment deterioration and infiltration.

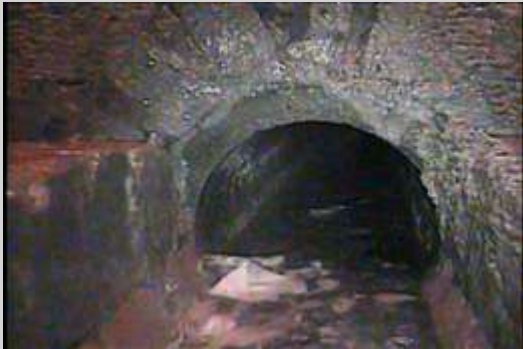
8 in. Circular Gravity Sewer Pipe Out @ 12 O'Clock

Deposits: ☐ None ☒ **Mud** ☐ Sludge ☒ **Debris** ☐ Grease

Silt Depth: **1** (in.) Deposits Extent: **Light**

Infiltration: **Evidence** Pipe Seal Cond: **Unknown**

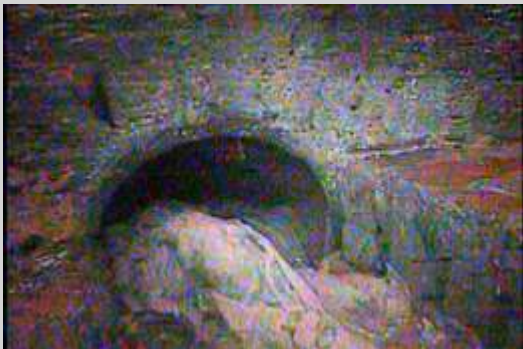
8 in. Circular Gravity Sewer Pipe In @ 3 O'Clock

Deposits: ☐ None ☒ **Mud** ☐ Sludge ☒ **Debris** ☐ Grease

Silt Depth: **4** (in.) Deposits Extent: **Medium**
